west virginia department of environmental protection

**CONSENT ORDER  
ISSUED UNDER THE  
WATER POLLUTION CONTROL ACT  
WEST VIRGINIA CODE, CHAPTER 22, ARTICLE 11**

TO: MarkWest Liberty Midstream & Resources, L.L.C.      DATE: March 28, 2019  
Gregory Bezdek, SVP, NE Region  
4600 J Barry Ct. Ste 500  
Canonsburg, PA 15317      ORDER NO.: 8945

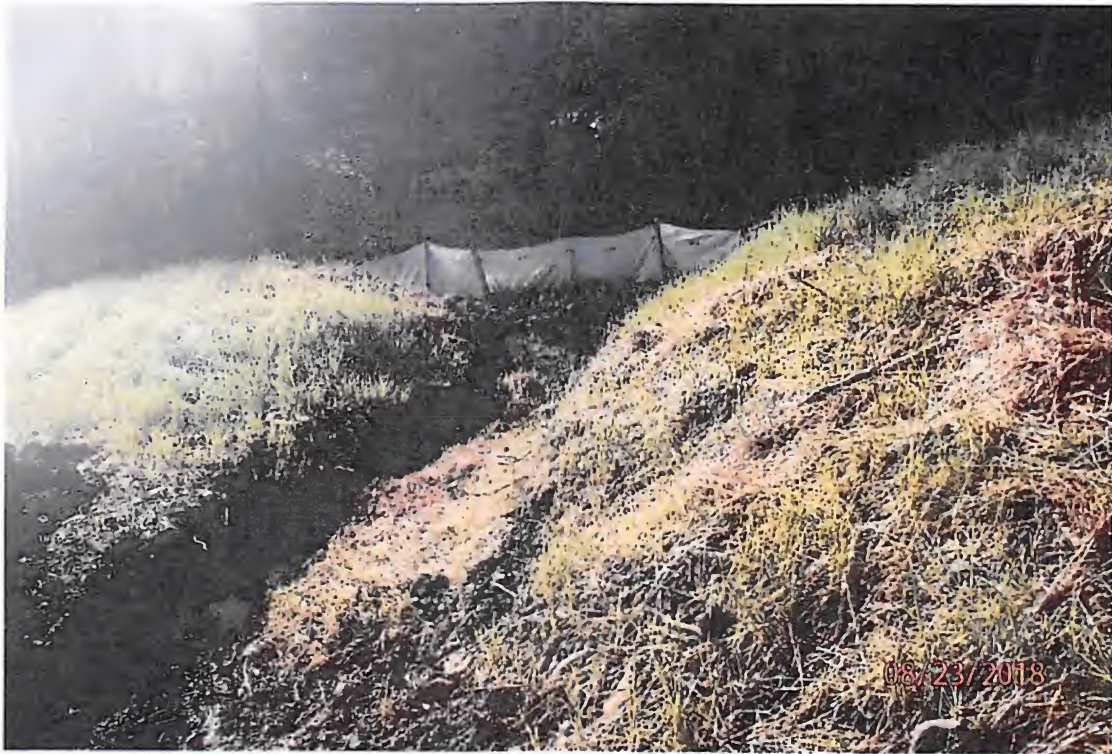
Overwhelmed water bar terminus BMP as a result of excessive erosion and increased water velocity from the above pictured water bar.

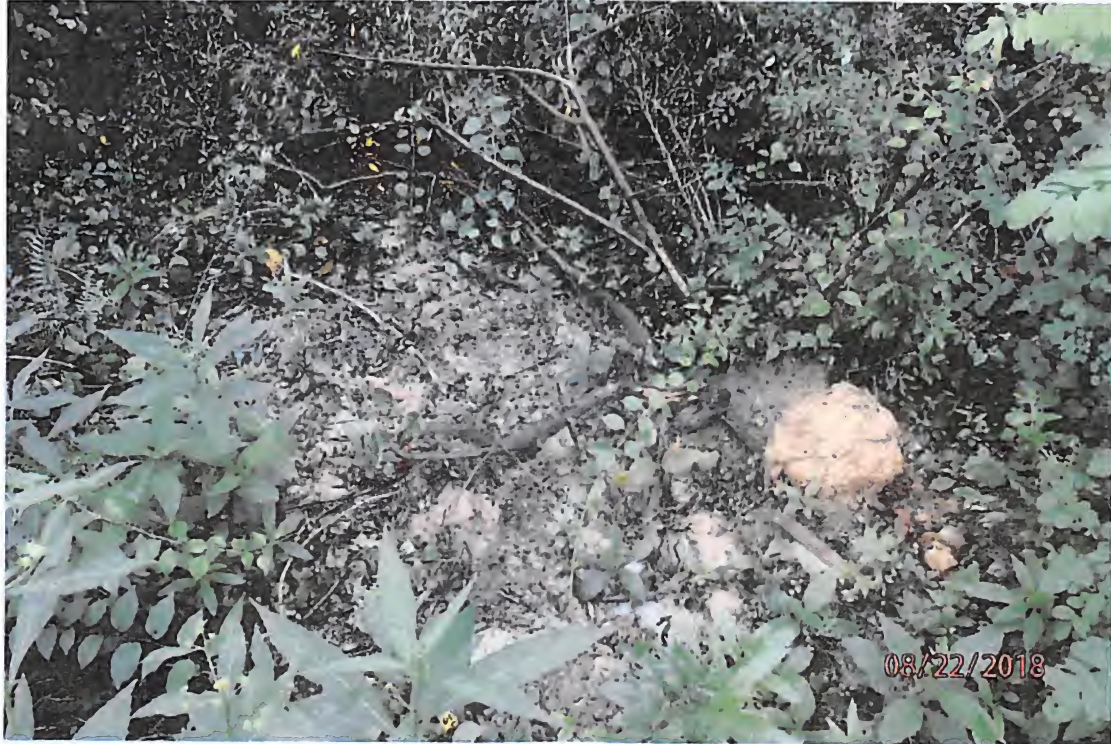
Offsite sediment deposits as a result of the above pictured deficiency.

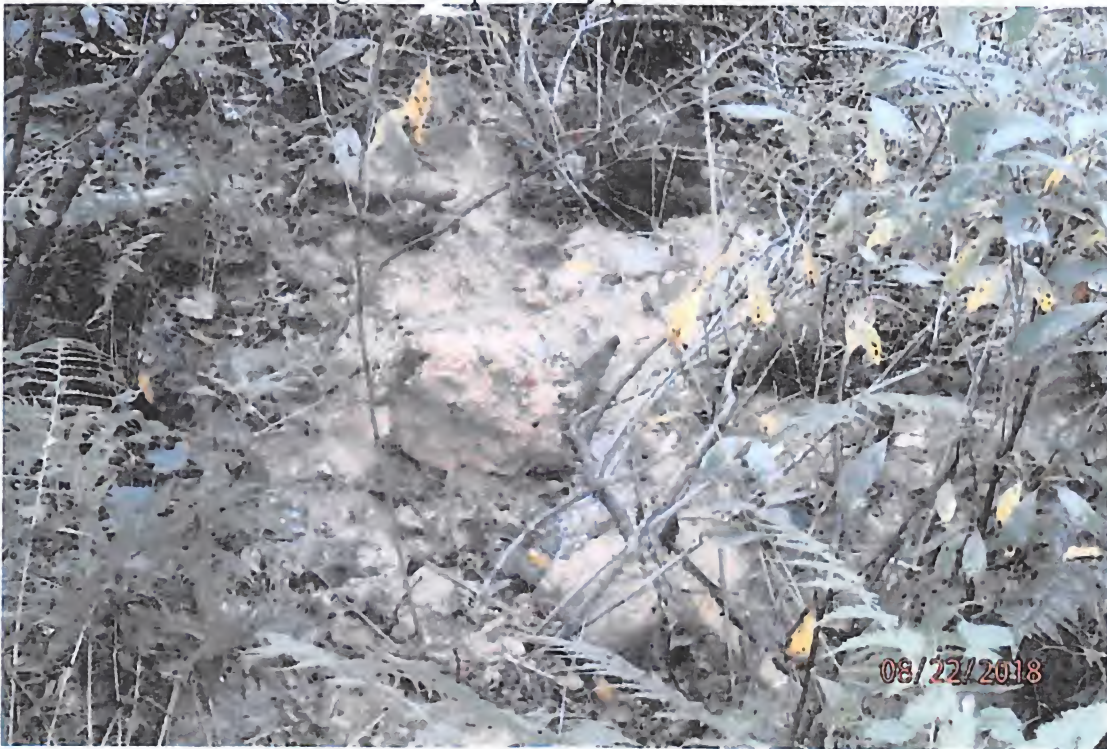
Offsite CNA deposits in UNT Righthand Fork of Morgans Run (UNT 108) (39° 17.955' X 80° 40.580')  
resulting from the previously pictured deficiencies.

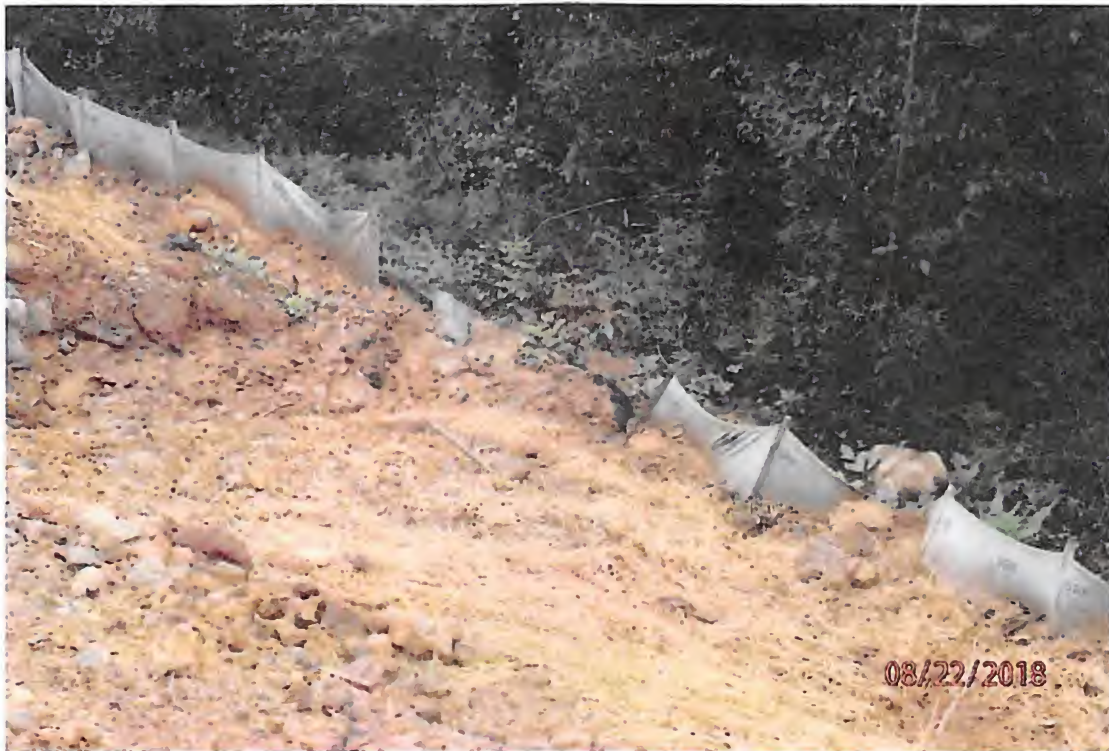
BMP that has been overwhelmed as a result of fill slope erosion.

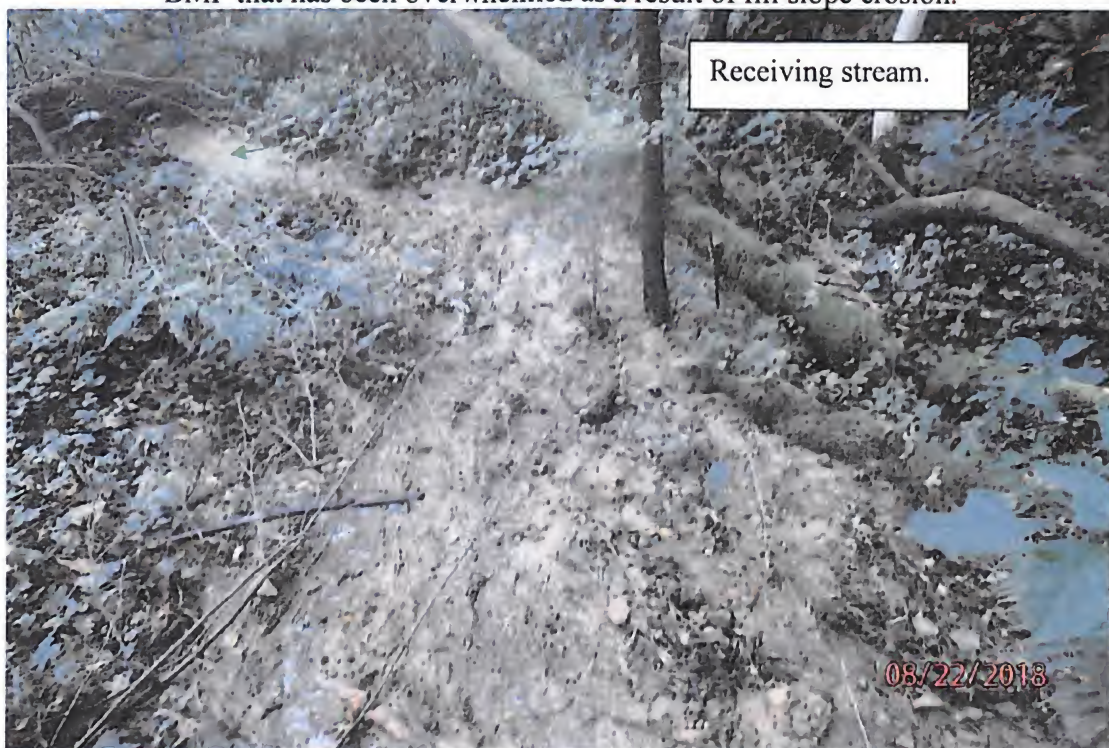
Offsite CNA deposits in UNT Righthand Fork of Morgans Run (UNT 108) (39° 17.955' X 80° 40.580')  
resulting from the previously pictured deficiencies.

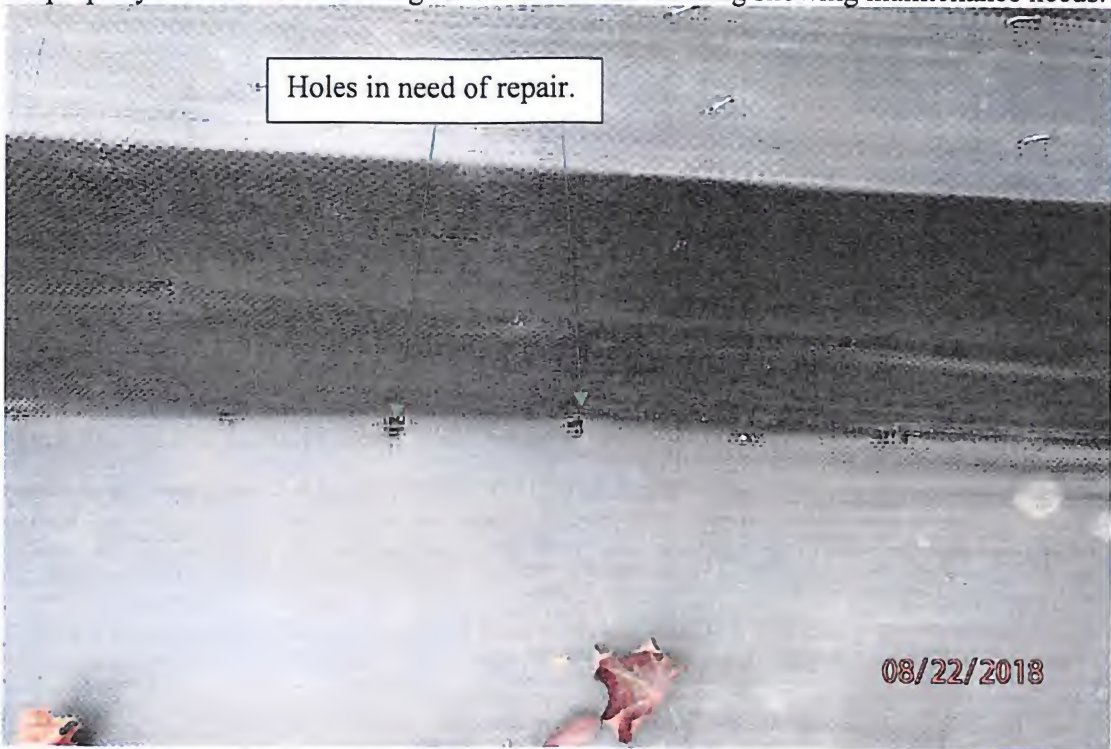
Improperly installed timber bridge at the Flint Run crossing showing maintenance needs.

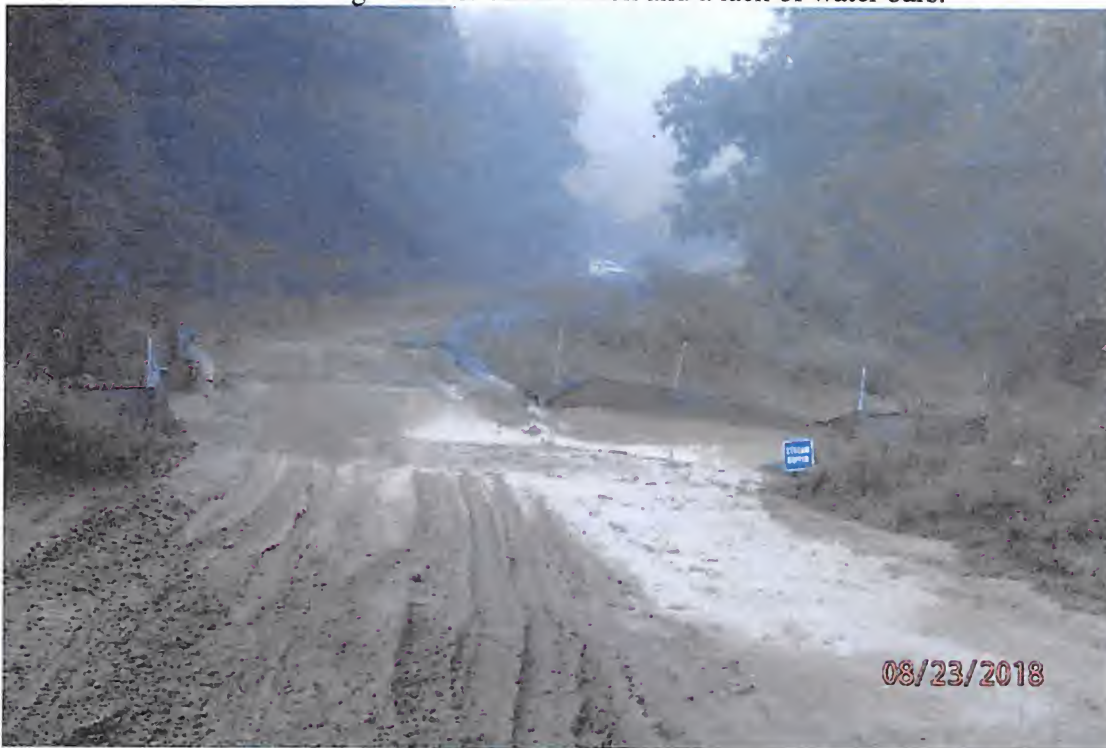
UNT 127 crossing on AR 40 showing area where CNA occurred as a result of above pictured deficiencies.

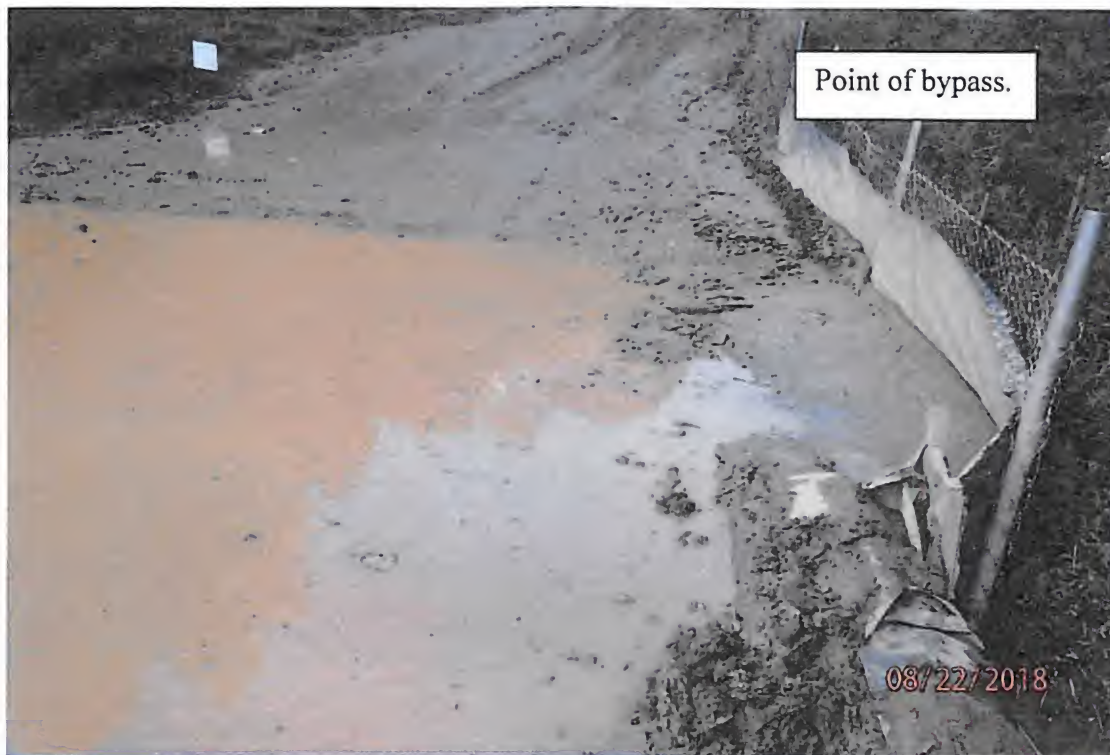
AR 40 crossing of UNT 127 where BMP failure allowed sediment to leave site into receiving stream.

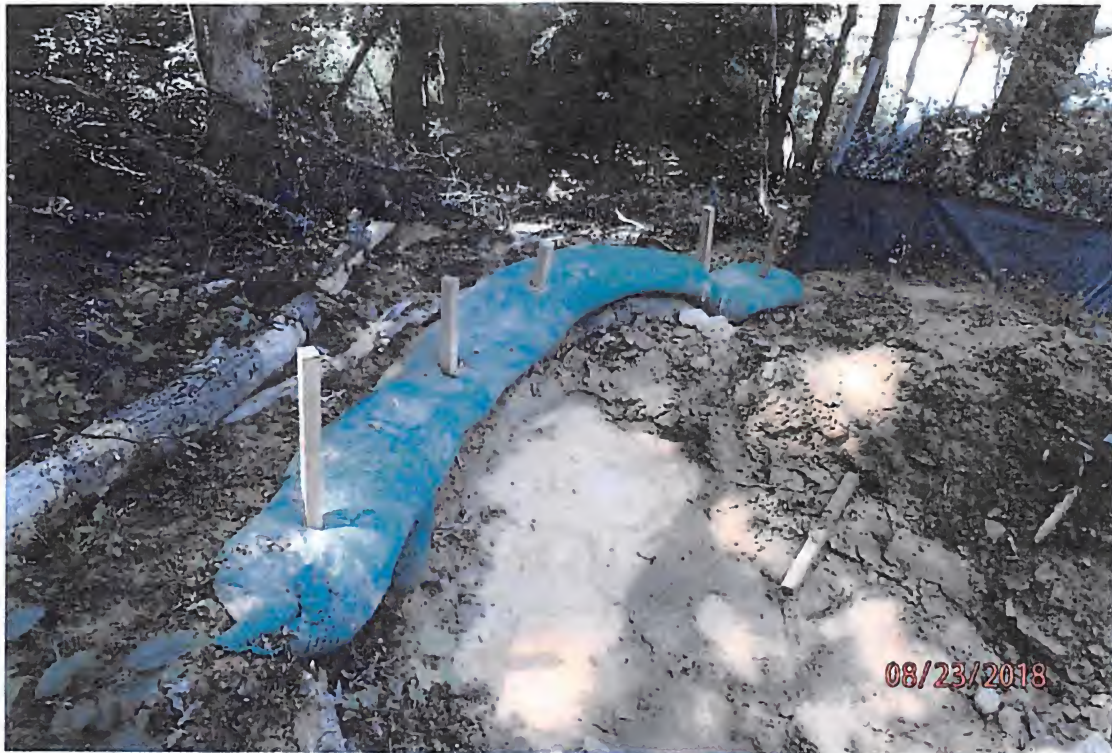
Improperly installed water bar terminus BMP that allowed sediment laden water to bypass it adjacent to crossing #23 (UNT 133).

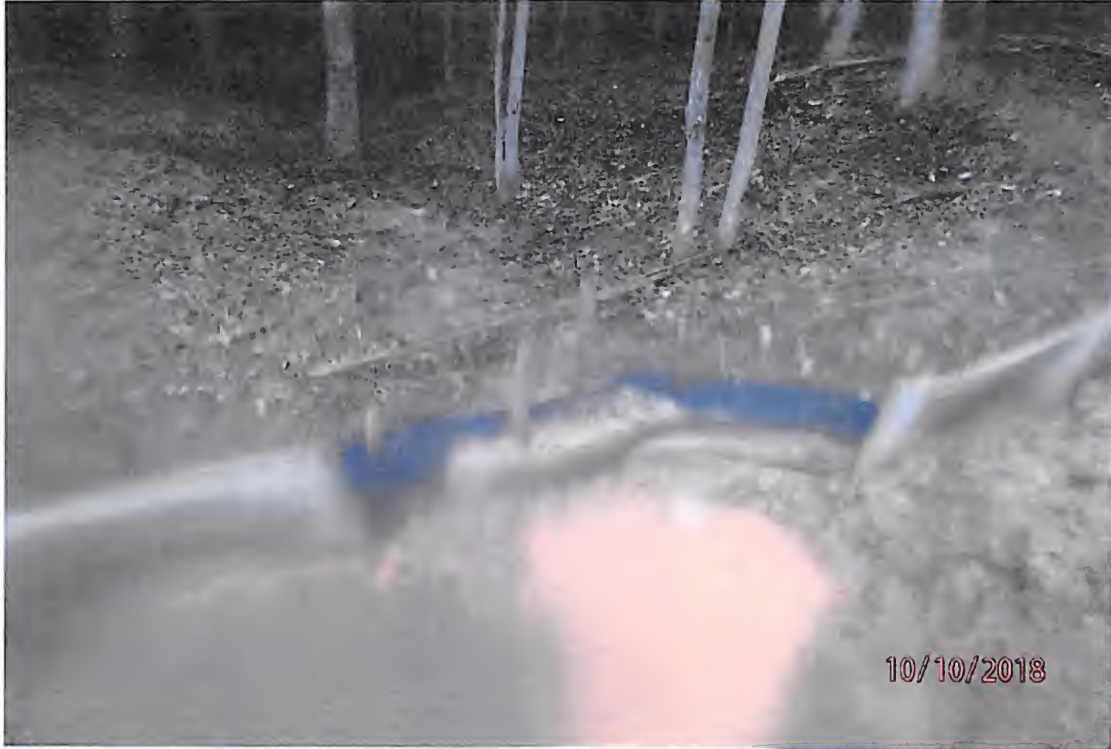
BMP in need of maintenance that caused CNA deposits in UNT Flint Run (39°21.161' X 80°39.549')

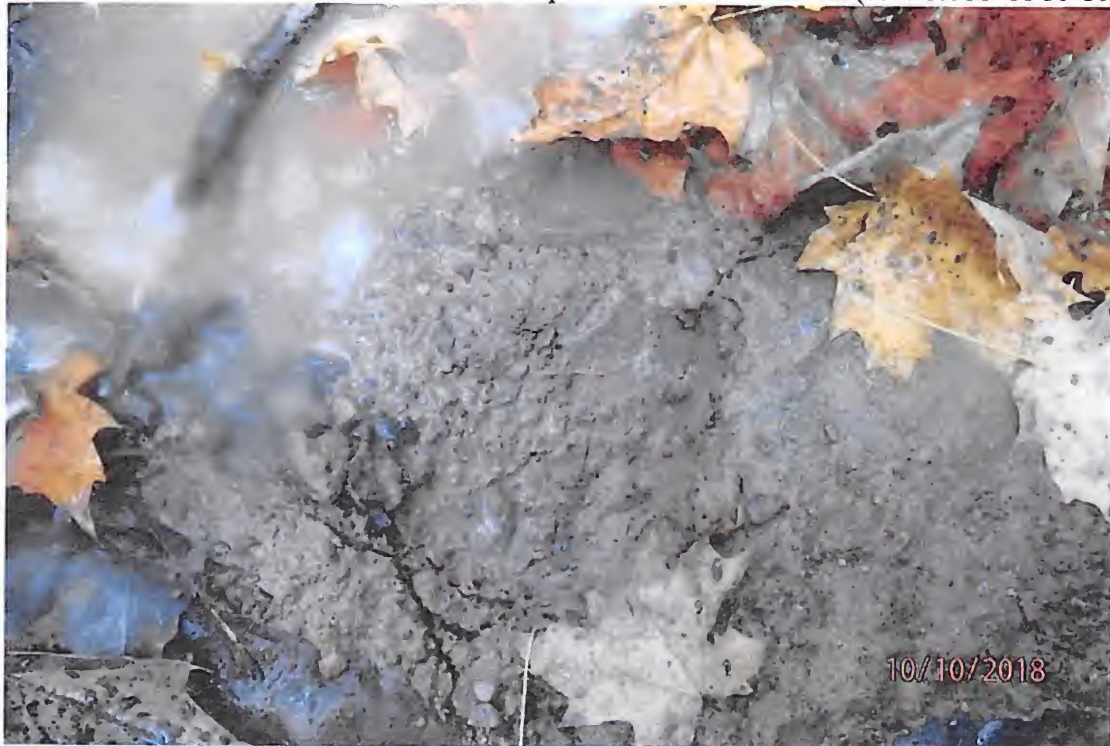
Offsite CNA deposits in UNT Flint Run (39°21.161' X 80°39.549').

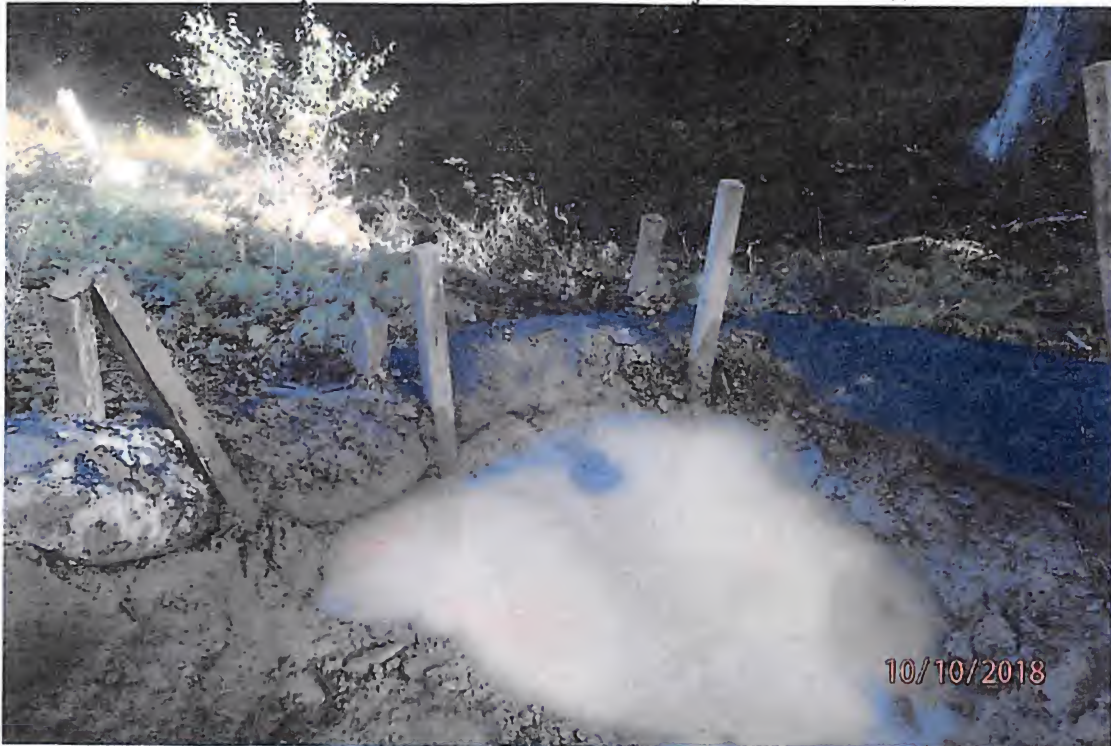
Installed water bar terminus BMP adjacent to 144+00 that caused offsite CNA deposits in UNT Morgans Run ( $39^{\circ}18.509'$  X  $80^{\circ}40.356'$ ).

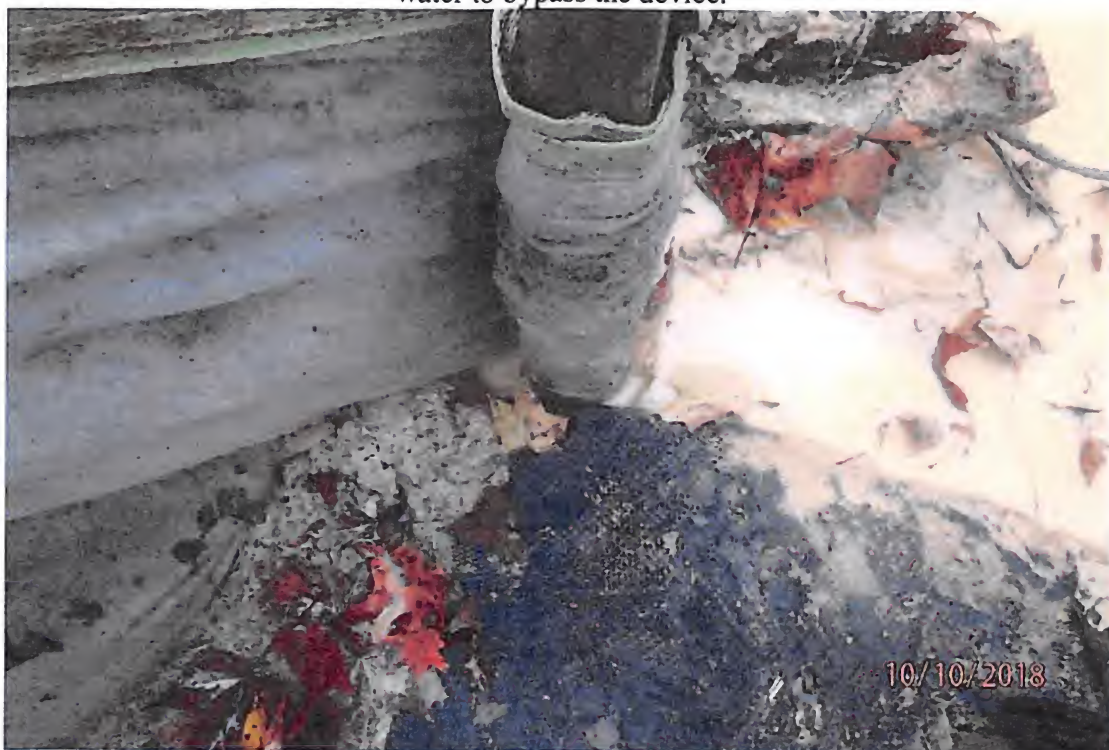
Improperly installed water bar terminus BMP in the Riggins Run watershed that allows sediment laden water to bypass the device.

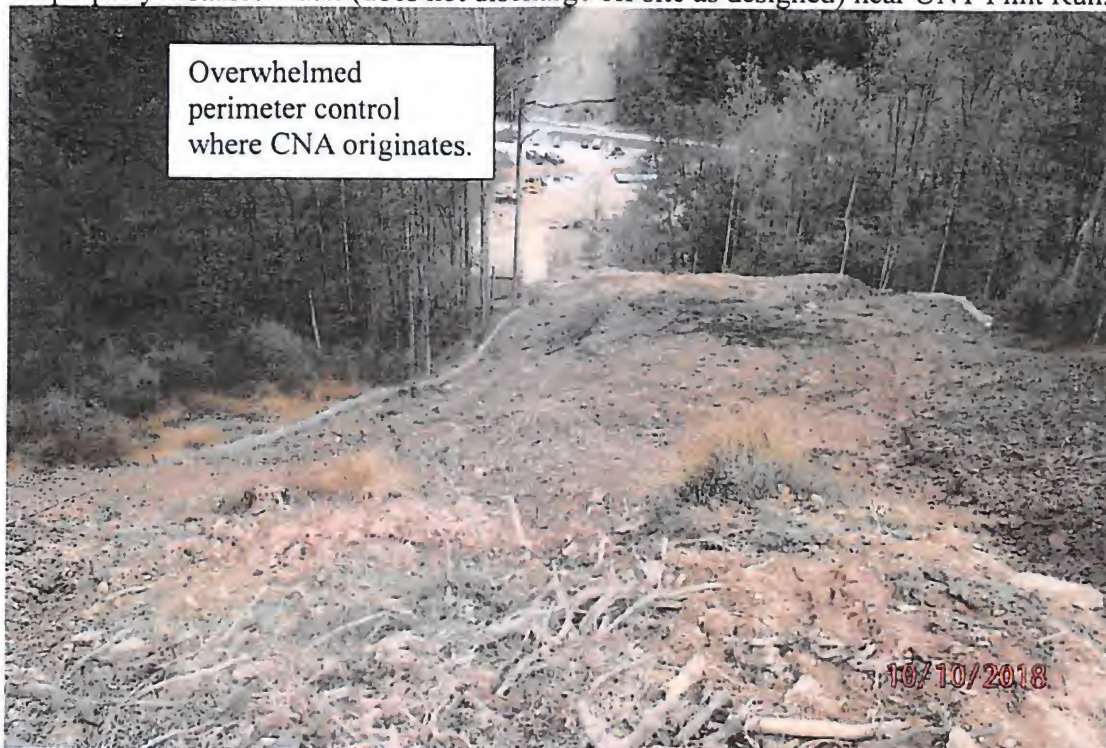
Area lacking properly installed water bars adjacent to UNT Flint Run. This caused excessive stormwater to overwhelm the installed BMP and caused CNA deposits in UNT Flint Run (39°20.058' X 80°39.931').

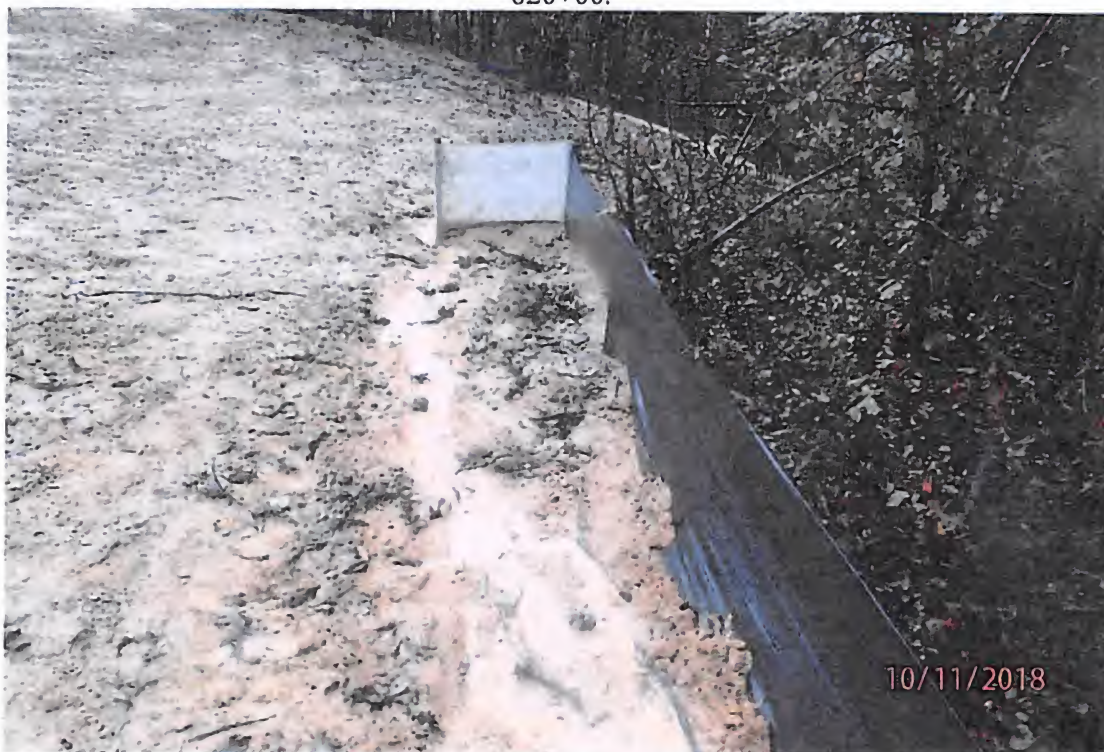
Concentrated flow stormwater following perimeter controls as a result of poorly constructed water bars near 820+00.

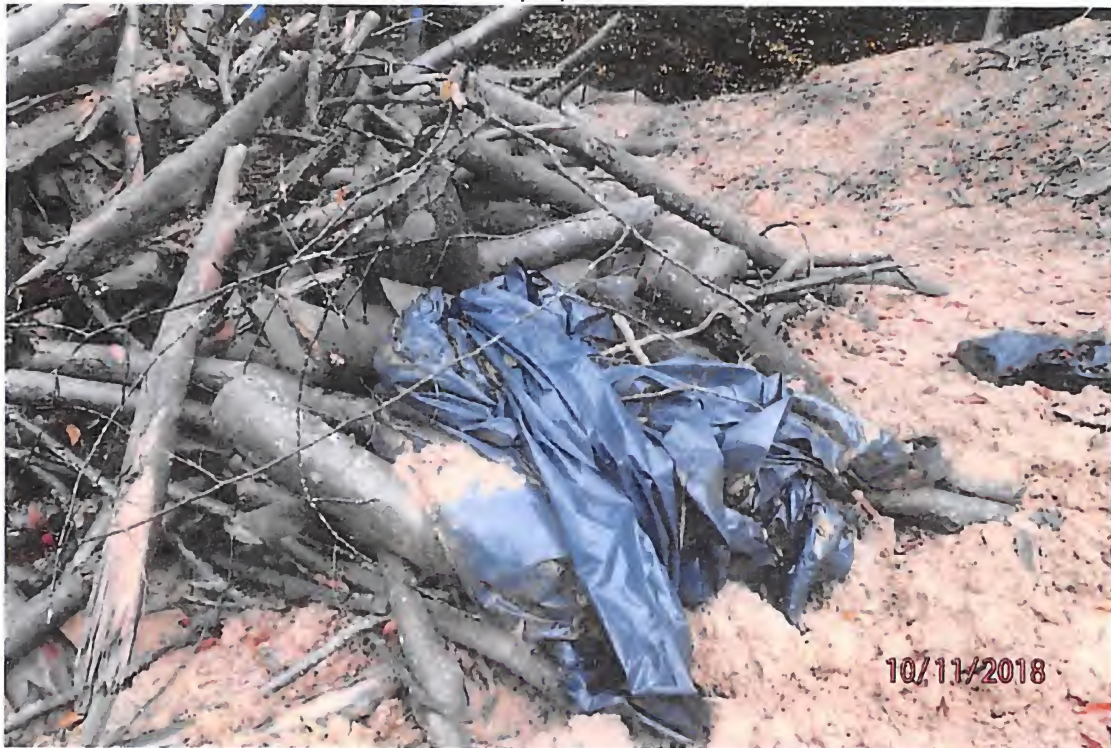
Trash on the right of way.
